## **"PRE-PURCHASE PROPERTY REPORT IN ACCORDANCE WITH APPENDIX C"**

As instructed, I have carried out an inspection of a two storey, six bedroom painted block / timber clad house in .....

## NORTHERN BUILDING INSPECTION CONSULTANTS

### 2.0 SUMMARY OF INSPECTION FINDINGS AND GENERAL OBSERVATIONS

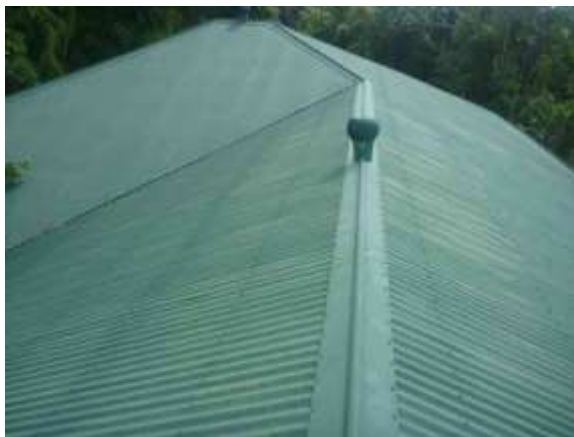
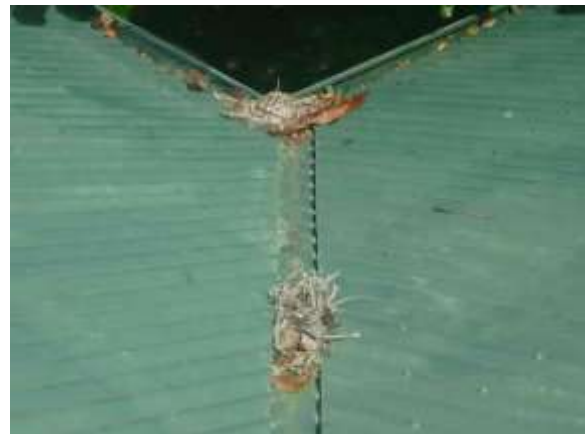
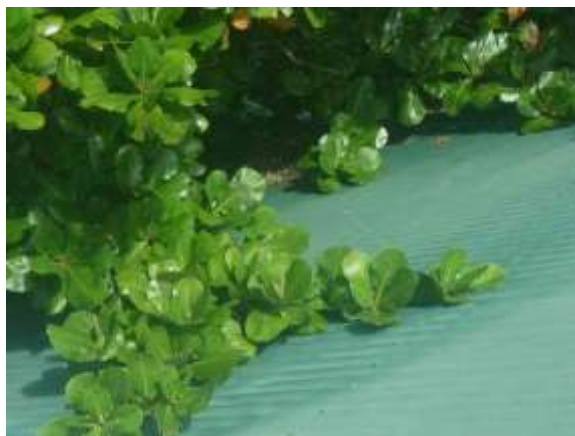
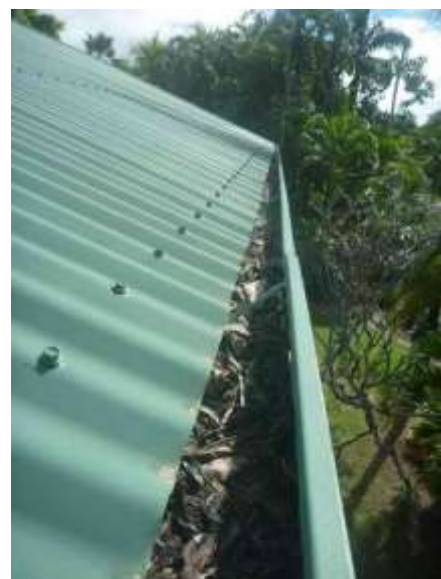
- (a) Up on the roof of the property the roofing iron and ridge caps were securely screwed down and the joins to the ridge caps pop riveted and sealed. The flashings to both the valleys and gables were in good condition but the gutters had foliage in them so they should be cleared to allow maximum water flow from the roof area and to prevent them from rusting out prematurely. I would also suggest that the tree branches overhanging the roof area are cut back to reduce the chances of this re-occurring. The rubber boots for the toilet vents were well sealed, as were the roof ventilators so no other obvious faults were noted here.

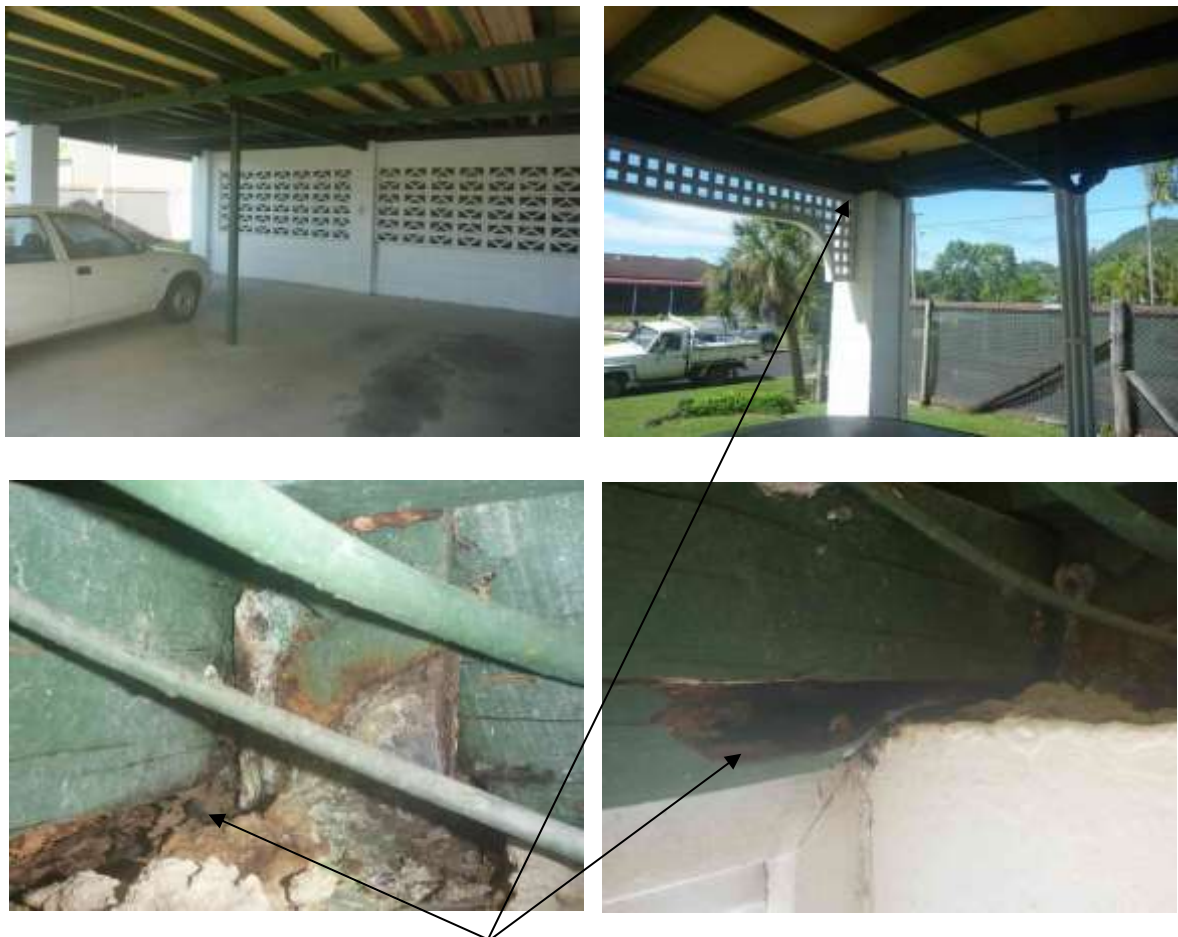
- (b) The double carport had unpainted concrete slab floor which was in good condition with the exception of the obvious stains and surface cracks to it. It sloped towards the access driveway so should drain adequately. The unlined ceiling had a single fluro light which operated well and the upper level floor here was supported by a combination of concrete pillars and steel posts supporting both steel and timber bearers and timber joists which were securely fastened to each other and in good condition for the most part their age. The ends of the two bearers in the front left hand corner of the carport had suffered fungal decay to the extent that they were no longer structurally sound so the services of an insured, registered builder should be employed to quote on the remedial work required to ensure that they become so.

Bearers decayed here

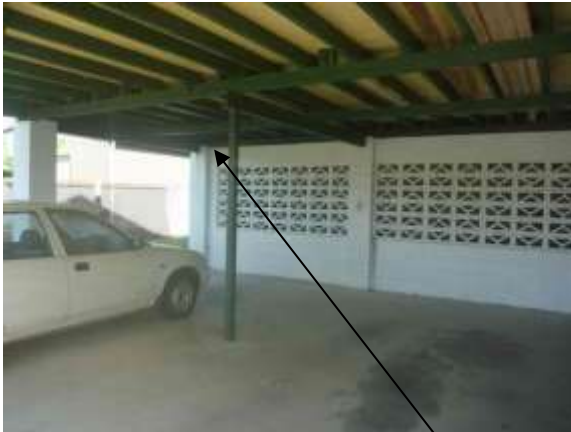
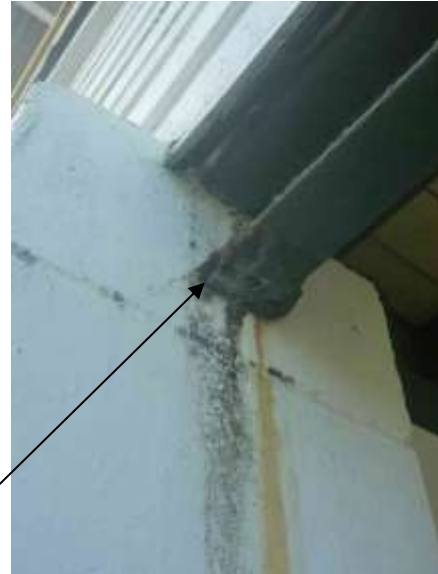
- (c) There was also a rusting steel bearer in the double carport, as shown below, which would also benefit from being rust converted and painted to prolong its life. No other obvious faults were noted here.

Bearer rusting here

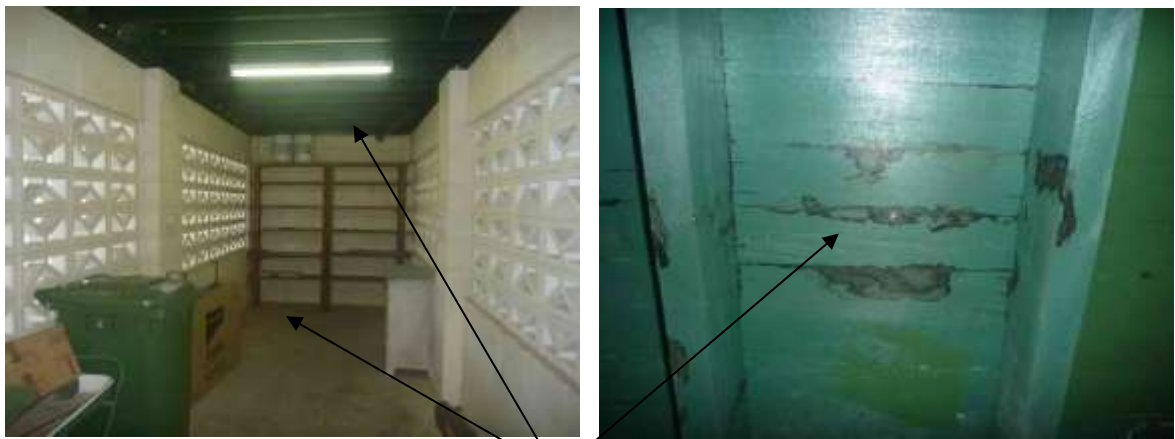
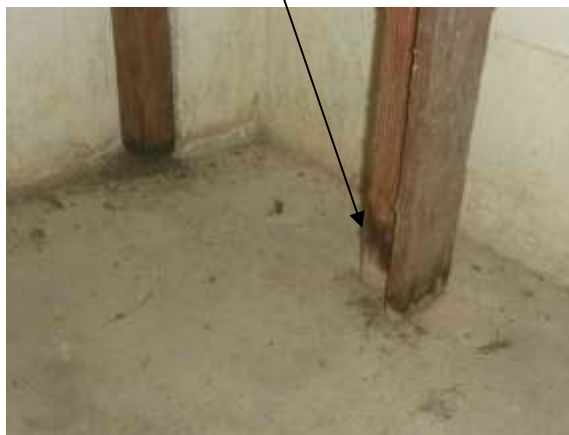
- (d) Stains were noted to the underside of the upper level floor in the storage room behind the carport which suggests a previous water leak in the upstairs kitchen. No excessive moisture was noted here at the time of the inspection which would suggest that the leak has previously been fixed but the base of the legs for the timber shelf were stained which also suggests water ingress to this area. I am unsure whether this is as a result of water blowing through the breeze blocks or from water seeping through the block work so you will need to be careful on what is stored in this room until you can ascertain whether it floods or not.

Water stains noted here

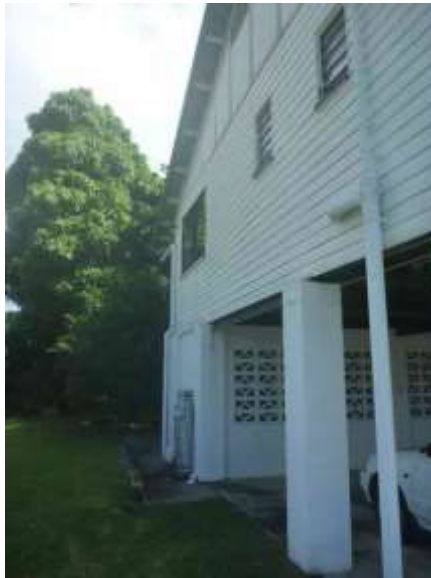
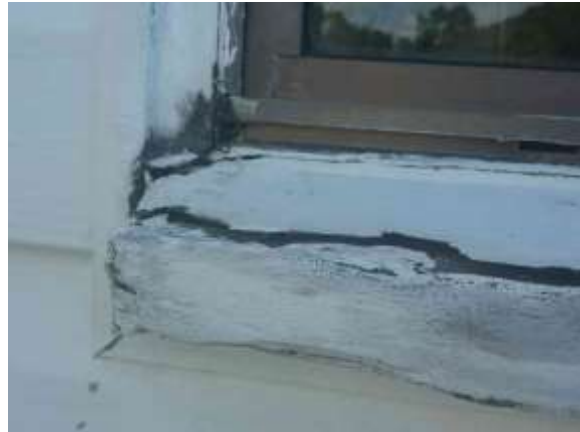
- (e) Looking down the left hand side of the house, from the road side, the landscaping sloped from back to front towards the road so drainage should be adequate for the most part. However, significant fungal decay was noted to the frames to the louvered windows so their frames will need to be replaced.

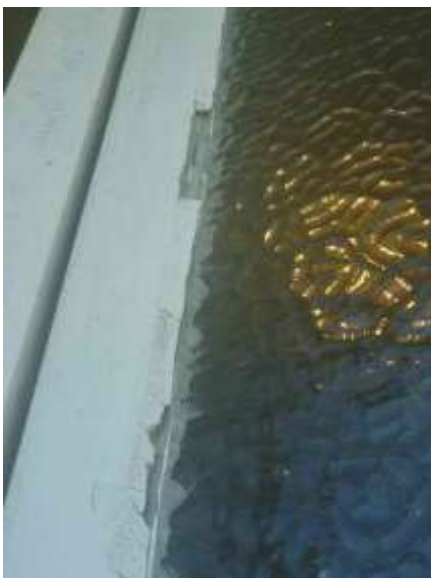
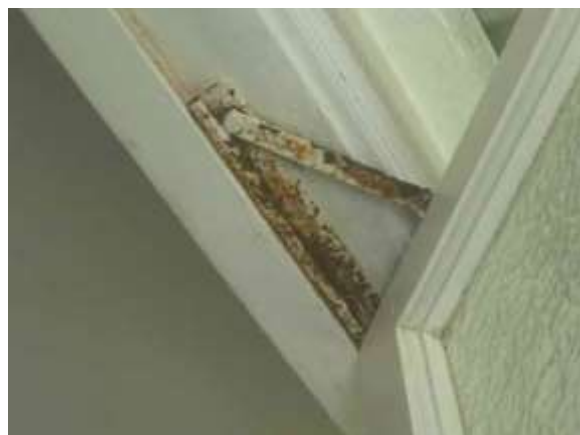
- (f) The putty for the timber casement windows had cracked and broken away in many areas and the window closers were starting to rust out as shown below. The windows are in need of some refurbishment work to be carried out on them so you should engage the services of an insured, registered tradesman to quote on this work for budgeting purposes.

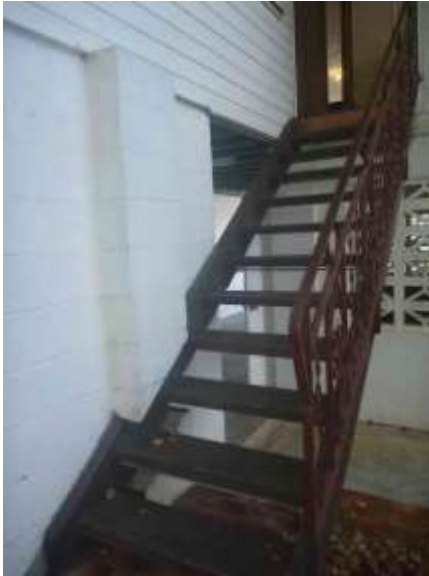
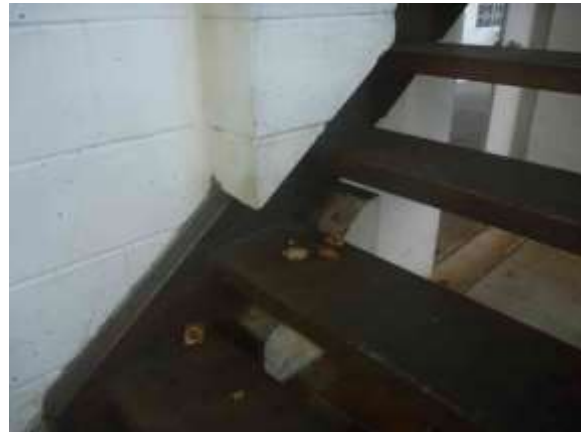
- (g) The gap down the left hand side of the staircase will need to be filled to prevent a child slipping through it. The cut engaged pier should pose no problems as it did not appear to be load bearing.

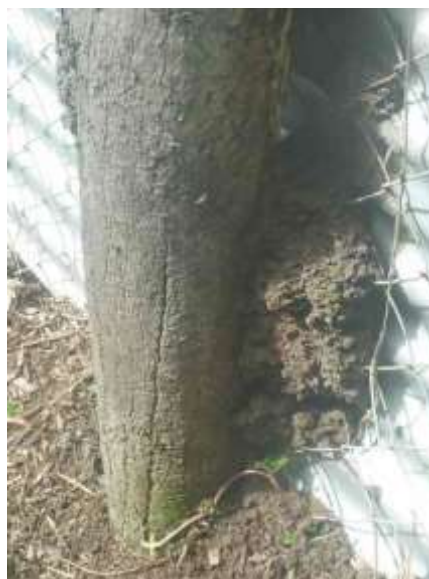
- (h) A couple of the fence posts down the left hand side of the block had been partially destroyed by previous termite activity so they will no doubt need replacing at some point in time.

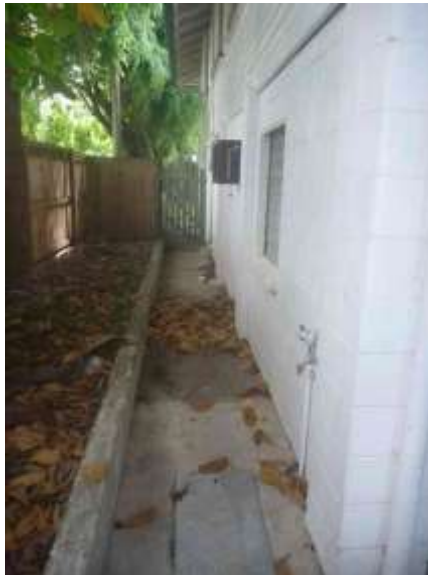
- (i) The concrete walkway at the back of the house was installed at the same finished height as the internal flooring of the downstairs living area which increases the chances of water ingress between the slab edge and first course of block work. This will be commented on in greater detail later in this report.

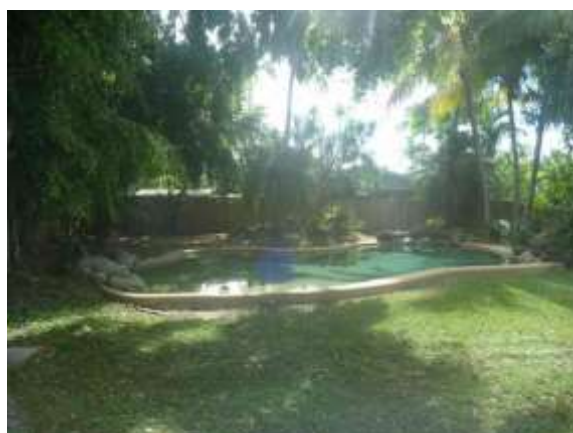
- (j) The pool was located down the right hand side of the block and it was surrounded by the timber boundary fences and the external walls of the house which did not comply with local council pool fence regulations as the pool area could be accessed directly from the inside living area of the lower level of the house. I suggest that you obtain a quotation for making the pool fence compliant for budgeting purposes.

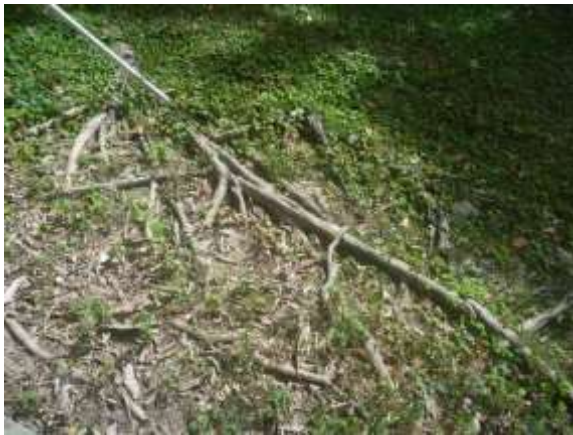
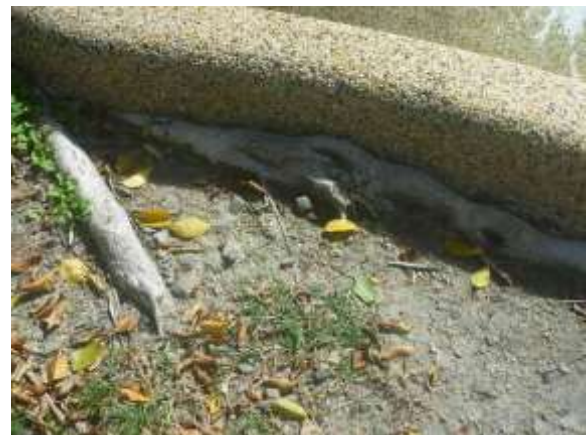
- (k) The roots for the fig tree behind the pool were migrating both towards the house and the pool which is not ideal as they drastically increase the chances of the slab for the house and the pool shell cracking. I would suggest that the tree and its root system be removed as soon as is practical so you should obtain a quotation for this work for budgeting purposes.

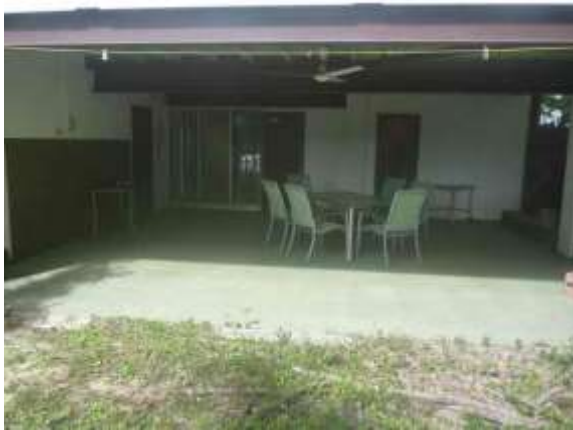
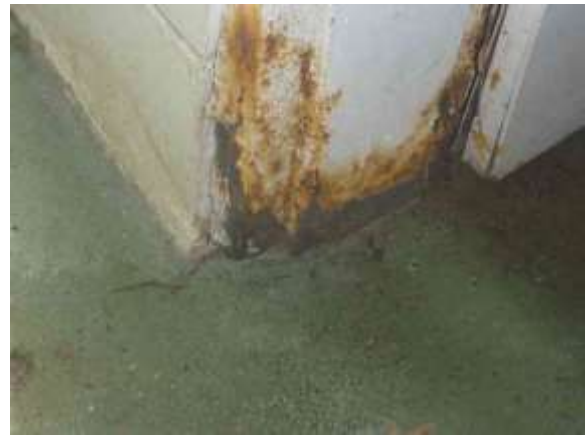
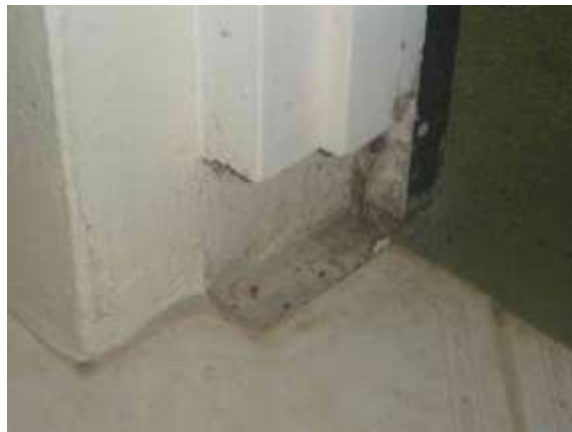
- (l) Although channel drains had been installed across the opening for the outside entertaining area I would suggest that the drainage here is inadequate as the door jams were both rusting out and suffering from fungal decay which suggests that water pools in this area. When the fig tree and its roots are removed I would suggest that you re-shape / re-level the landscaping down the right hand side of the house so that all excess water from this area drains down the right hand side of the house and to the road side. Please budget for this work accordingly.

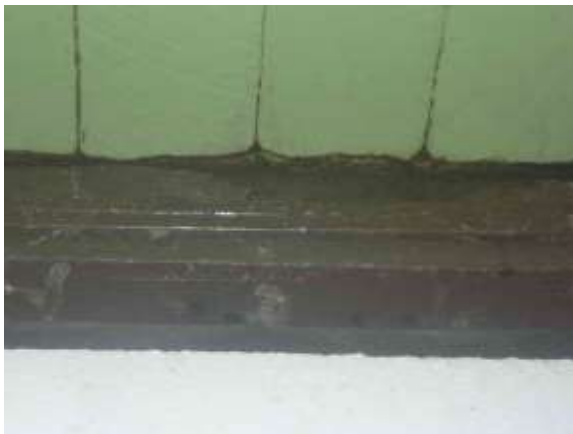
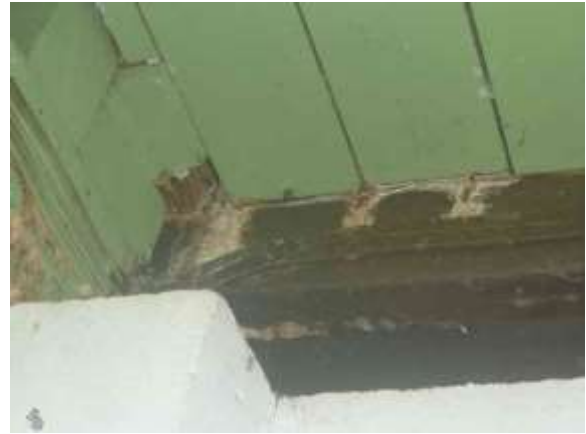
- (m) Water staining and excessive moisture was noted to the underside of the floor boards / the joist beneath the upstairs bathroom above the undercover area so the services of a professional water proofing company / plumber should be engaged to investigate this further and quote of the remedial work required to make it water tight.

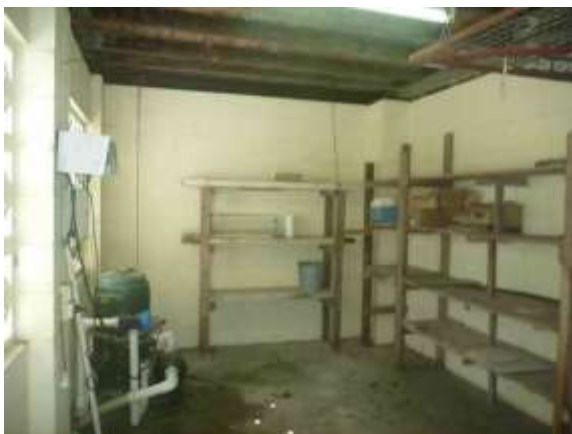
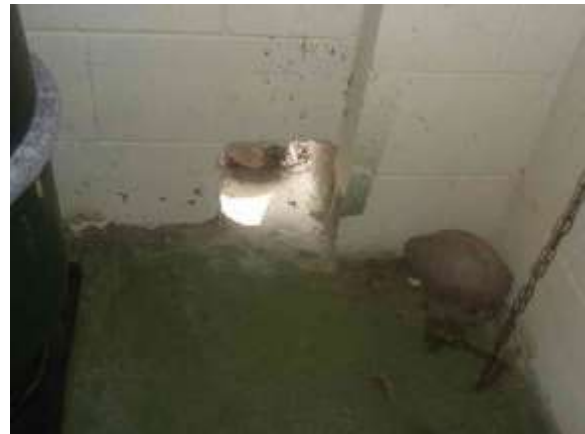
- (n) Only one of the two fluoro lights for the lower outside entertaining area were working at the time of the inspection (one needed a new starter) but the fan operated well so no other obvious faults were noted here.
- (o) A hole was cut in the external block wall of the storage room which again suggests that it floods.

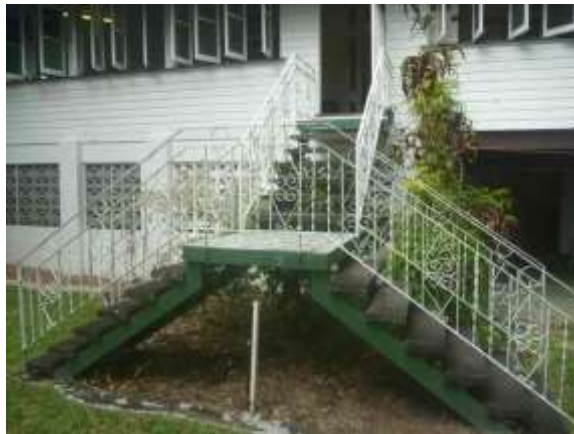
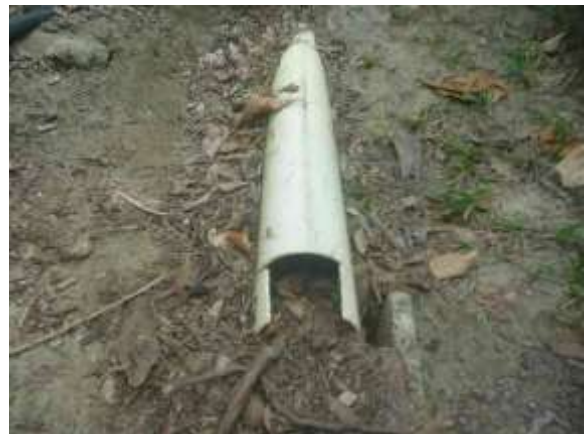
- (p) The staircase leading to the upper level of the house from the pool area appeared to be in good condition but the storm water pipe here appeared to be blocked which should be investigated further by an insured registered plumber.

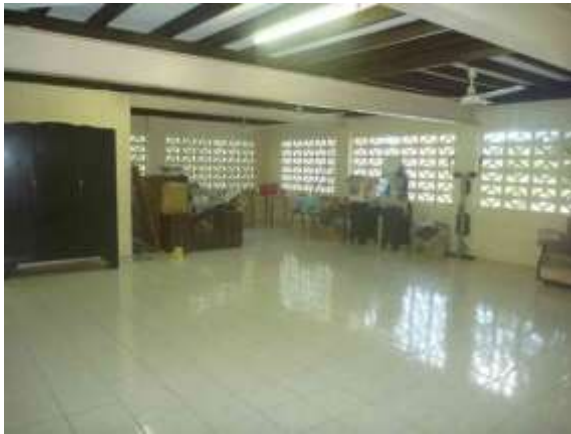
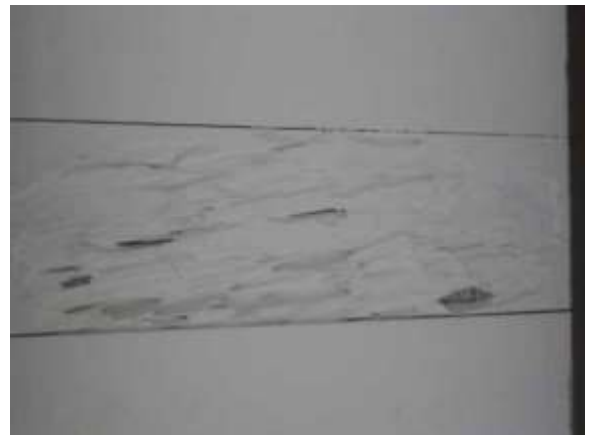
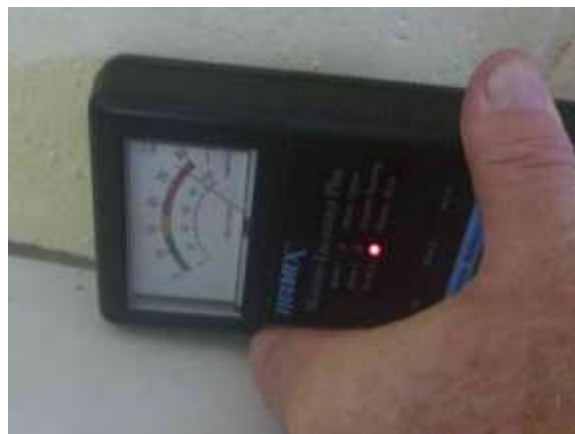
- (q) The downstairs lounge and dining area had four lights and seven fans which all operated well. However, dry wood termite damage was noted to a section of the underside of the upper level flooring here which I would suggest will need to be replaced so please budget for this work accordingly. Also, excessive moisture was noted on the inside of the external walls which suggests that water is being drawn through the block work in a capillary action so the services of a professional water proofing company should be engaged to investigate this further and quote on the remedial work required to make the lower level of the dwelling completely water tight. The sub structure for the remainder of the upper level floor here appeared to be in good condition so no other obvious faults were noted here.

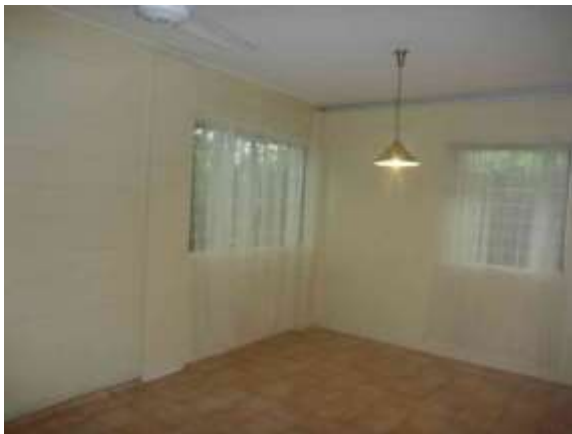
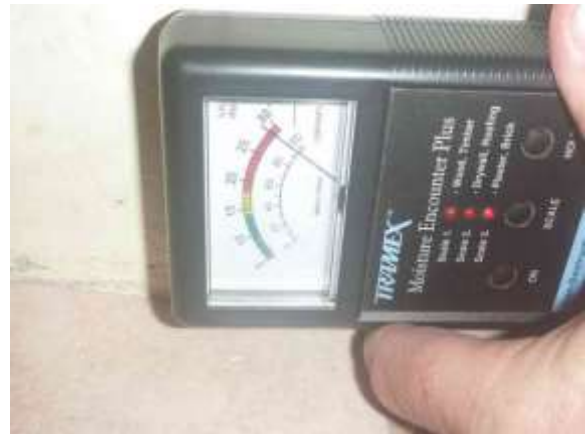
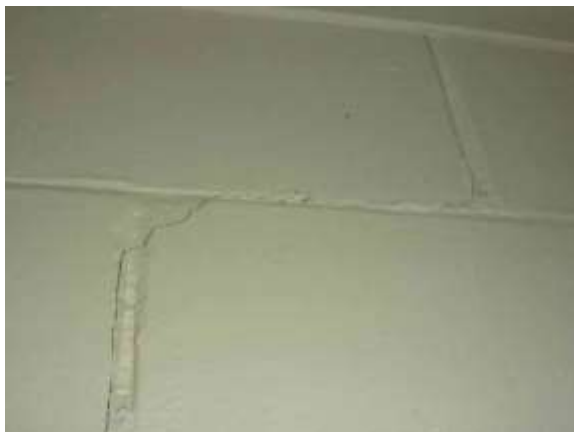
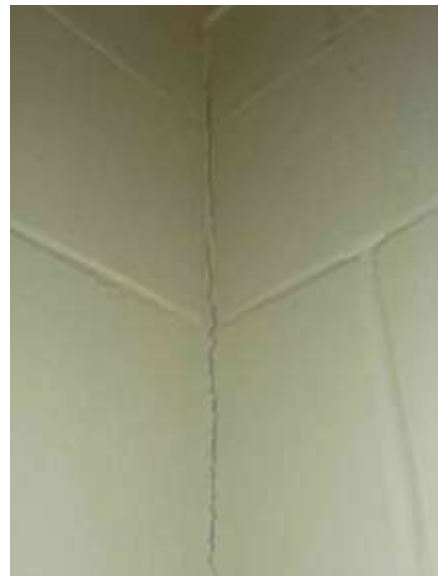
- (s) The first bedroom faced the back of the property and it had single light and a fan which both operated well. The windows facing the side and back of the property closed and latched into place but once again excessive moisture and blistered paint was noted on the inside of the external walls which suggests that water is being drawn through the block work in a capillary action. As stated earlier the services of a professional water proofing company should be engaged to investigate this further and quote on the remedial work required to make the lower level of the dwelling completely water tight. Also, there were two cracks in the internal block walls here which have most likely been caused by some movement to the property at some point in time (which is common to see in domestic construction where no expansion joints are used). They are unlikely to increase in size much further but if you are at all concerned about them please seek further advice from a qualified, practising structural engineer. No other obvious faults were noted here.

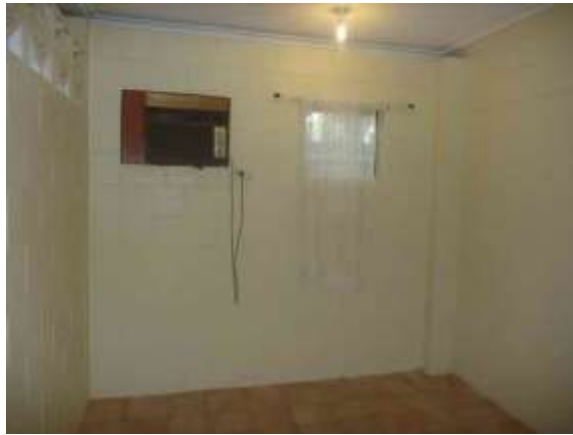
- (t) The second bedroom had a single light, a fan and a wall unit air conditioner which all operated well and again the windows facing the back of the property closed and latched into place. Excessive moisture and blistered paint were noted on the inside of the external walls which confirms the need for the lower level of the dwelling needing to be re-water proofed.

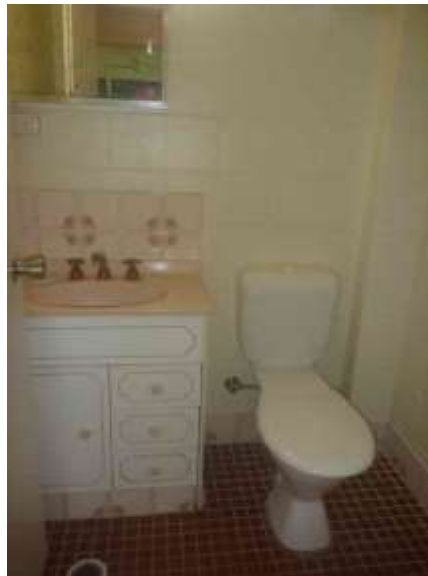
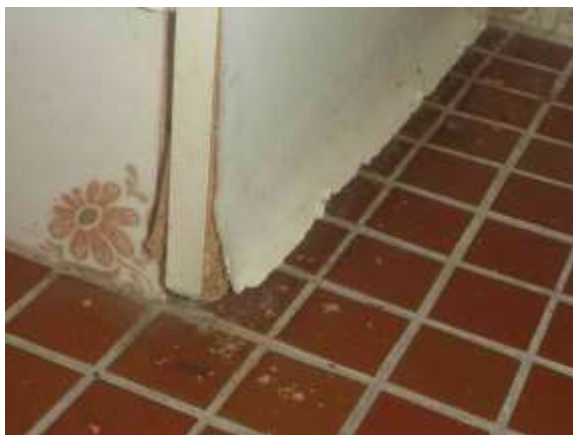
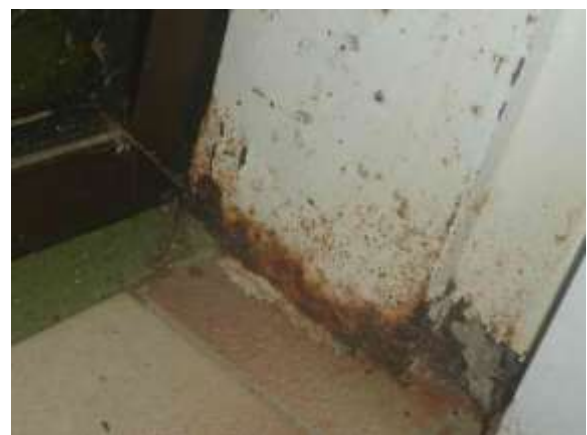
- (u) The downstairs bathroom had a single sink vanity unit with laminated doors and draws beneath which were in poor condition with obvious moisture swelling and delamination noted to various sections of the unit (realistically it needs replacing). There was ample water pressure to the fixtures, good sealant to the splash back tiles and no signs of leaks were noted beneath the sink. The shower had ample water pressure to its fixtures and the toilet was secure, flushed and did not leak. However, the base of the door jamb leading to the outside entertaining area was rusting out and the door to access the kitchen area would not close which again suggests a drainage / flooding problem here.

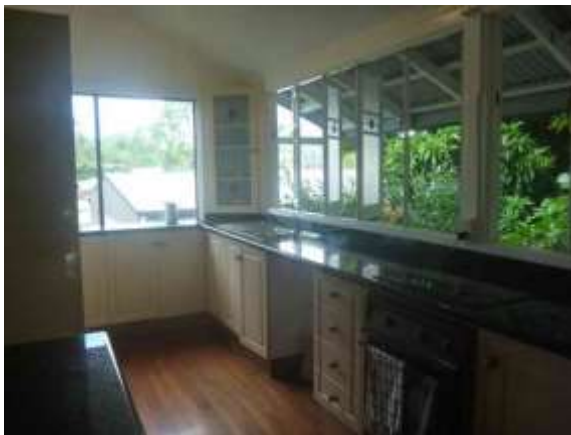
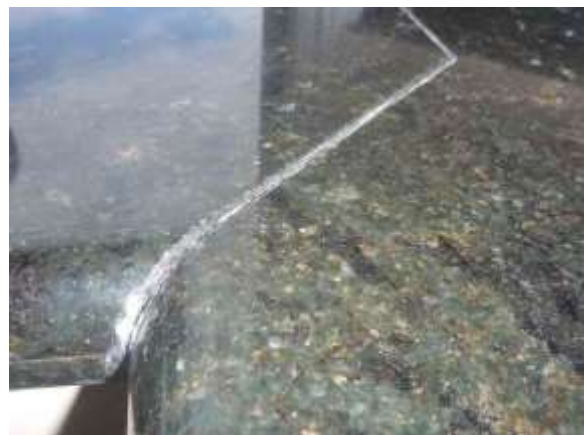
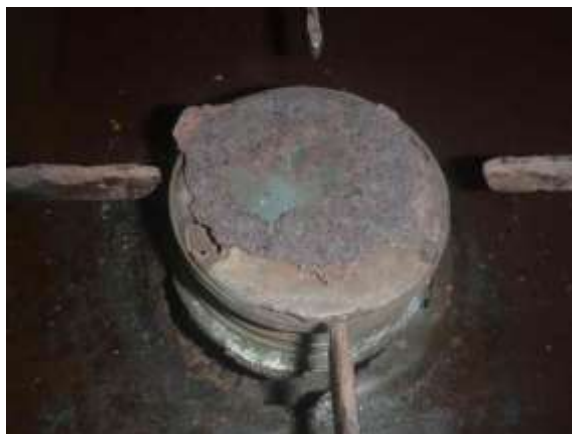
- (w) The kitchen had granite bench tops with laminated doors and draws beneath which were in just fair condition for their age with obvious gaps between the joins of the bench top where the floor level has dropped at some point in time. The kitchen had a one and a half stainless steel sink with flick mixer which had ample water pressure and no signs of water leaks were noted beneath the sink. The four burner gas cook top could not be tested due to the lack of ignition source (the burners were clearly rusting out though) but the oven beneath operated well and the windows facing the back of the property closed and latched into place. They were however extremely difficult to move confirming the need for their refurbishment. The lights and fans were in good working order, as was the light in the pantry which had secure shelving so no other obvious faults were noted here.

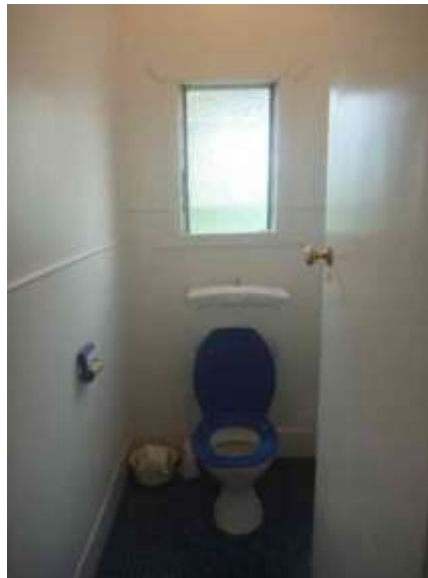
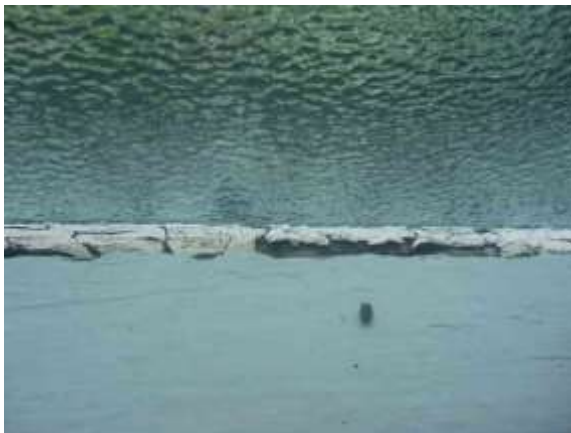
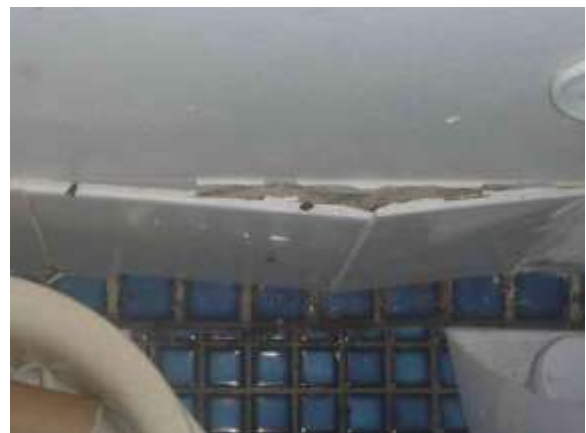
- (aa) The separate toilet was secure, flushed and did not leak but the windows facing the side of the property were seized shut. As stated earlier, their frame was decayed so they will need replacing anyway. Also, the skirting tiles were popping off the wall here which will also need replacing.

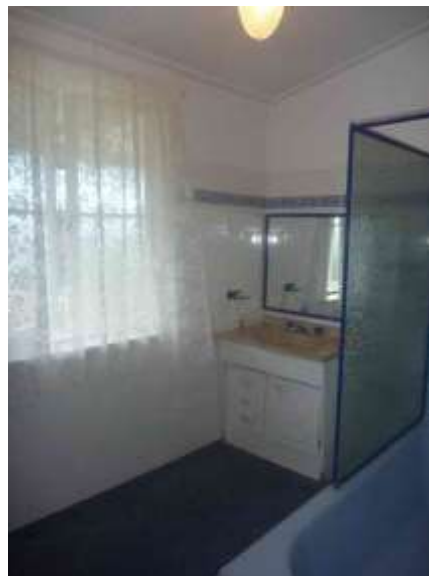
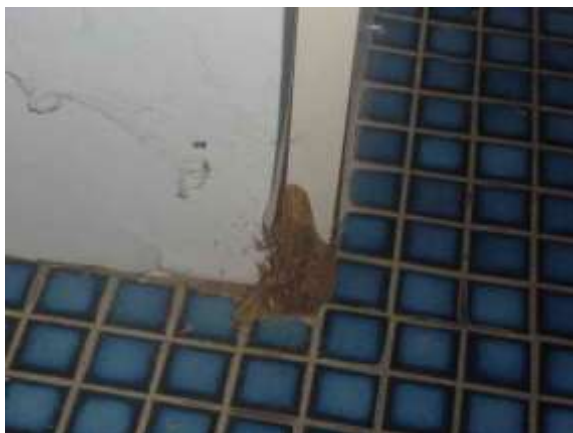
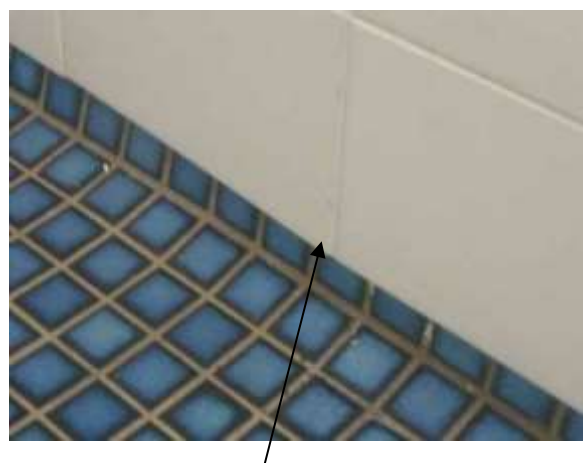
- (bb) The bathroom had a single sink vanity unit with laminated doors and draws beneath which were in poor condition with obvious moisture swelling and delamination noted to various sections of the unit. There was ample water pressure to the fixtures, good sealant to the splash back tiles and no signs of leaks were noted beneath it. The bath with shower above had ample water pressure to their fixtures and both units were well sealed with no leaks noted to either one. The light operated well but once again the skirting tiles were popping off the wall which will need replacing. No floor waste was visible here so I am unsure where excess water would drain to in the event of a flood but no other obvious faults were noted here.

Tiles popping off wall

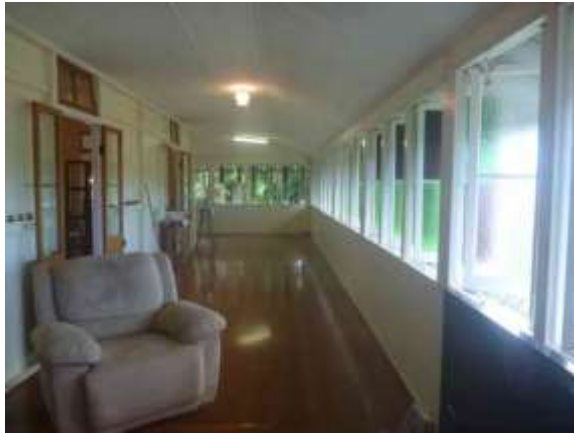
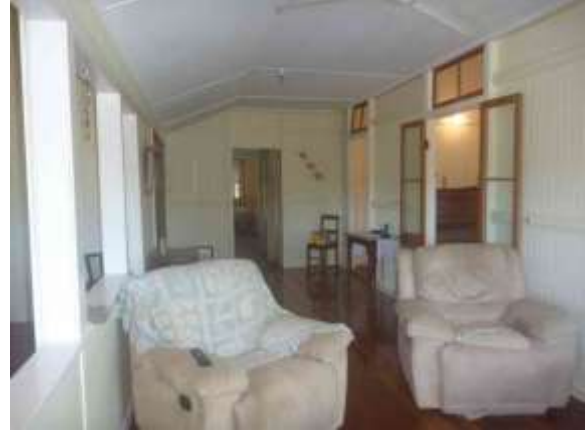
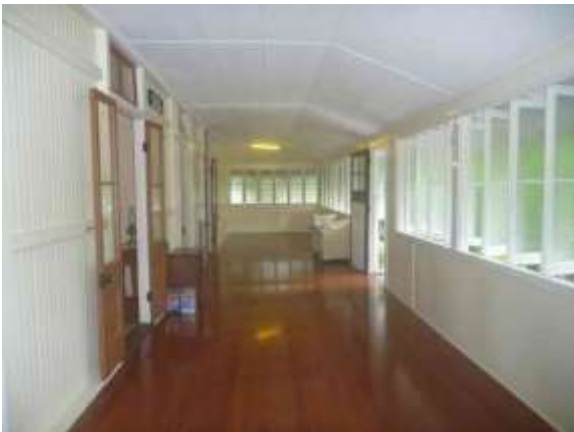
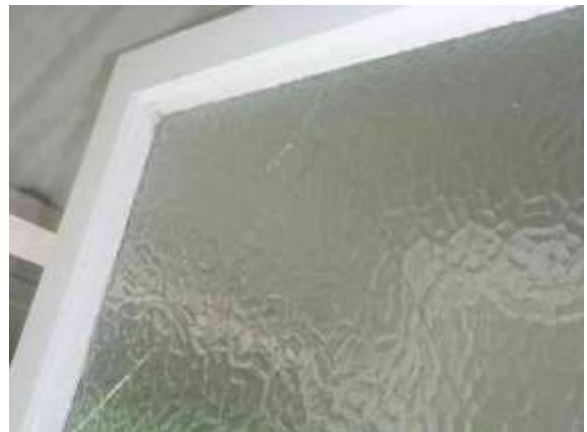
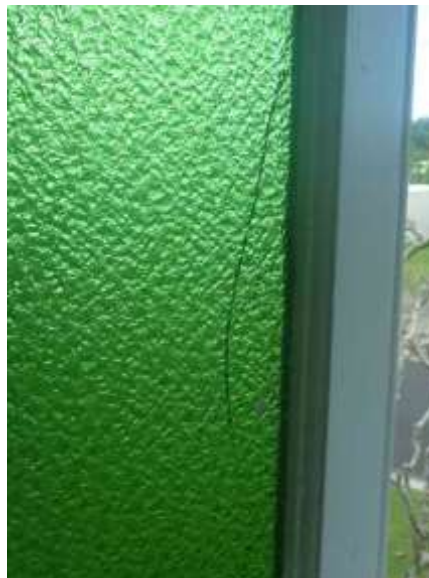
- (cc) With the exception of the two cracked panes of glass in the lounge areas, no other obvious faults were noted here.

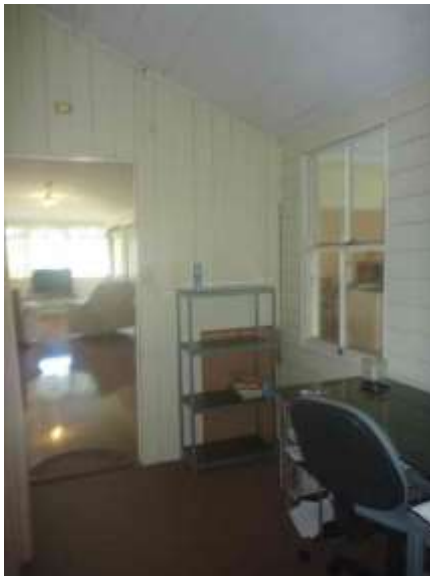
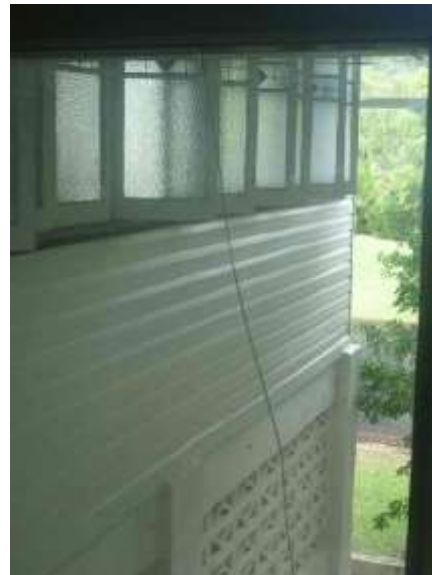
- (kk) Apart from the cracked pane of glass in the office area needing to be replaced, no other obvious faults were noted here.
