Visual Timber Pest Inspection & Report in accordance with AS 4349.3-2010
(For use in all States & Northern Territory but not the Australian Capital Territory)

VISUAL TIMBER PEST REPORT

1.1 Building Type: Free Standing Domestic House. Height: The structure is: **Two Storey**

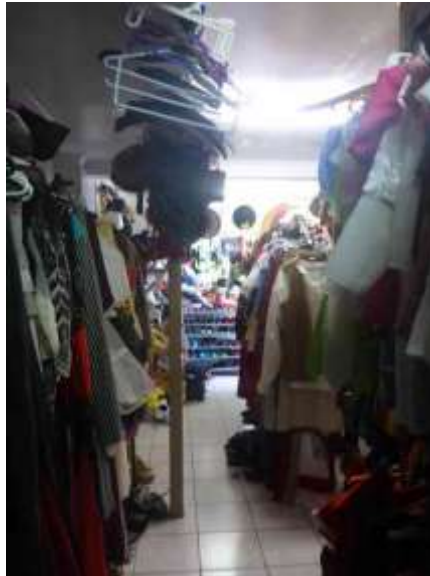
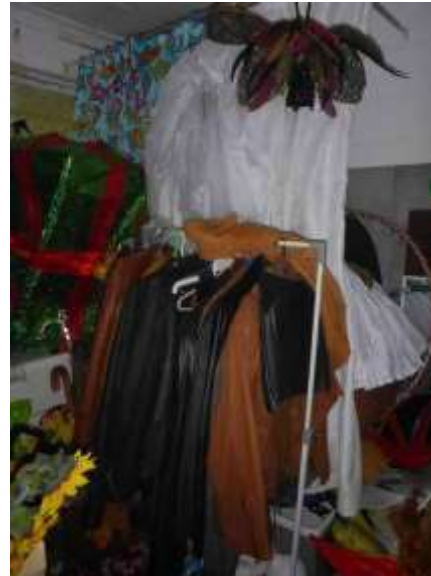
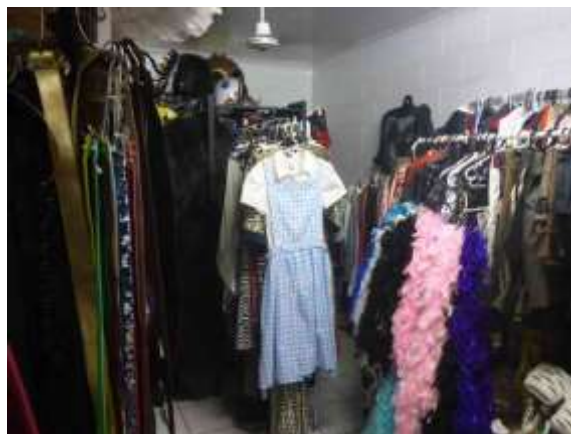
The majority of the internal walls of the house were not visible due to the amount of stored personal items. The downstairs area in particular was being used to run a costume business so access here was extremely limited.

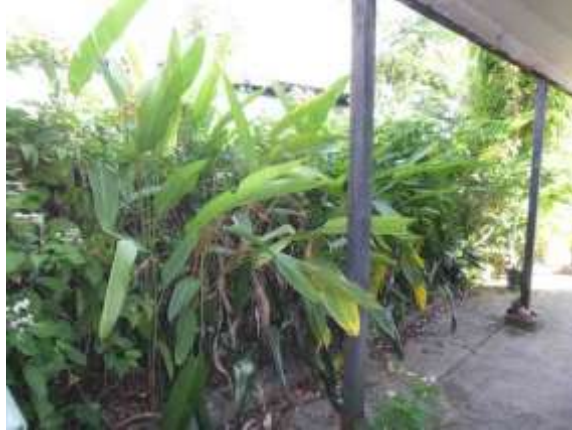
Not all sections of the boundary fence were visible due to the dense foliage covering them.

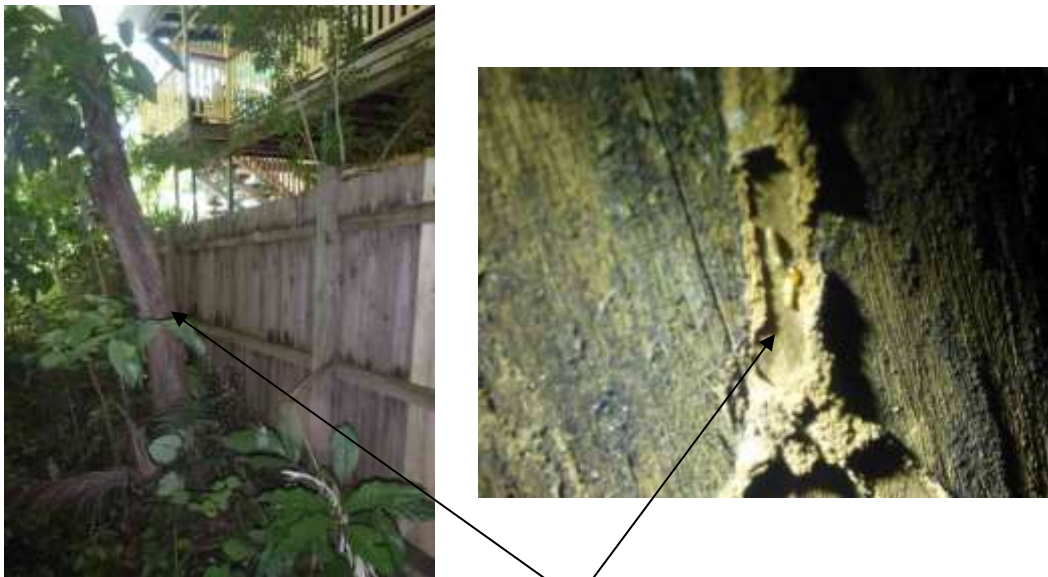
Live termites were sighted in a decaying tree stump in the back left hand corner of the block.

Live termites in workings

Additional Comments: **Recommend that the known areas with active termites be treated by a licensed pest controller as soon as is practicable.**

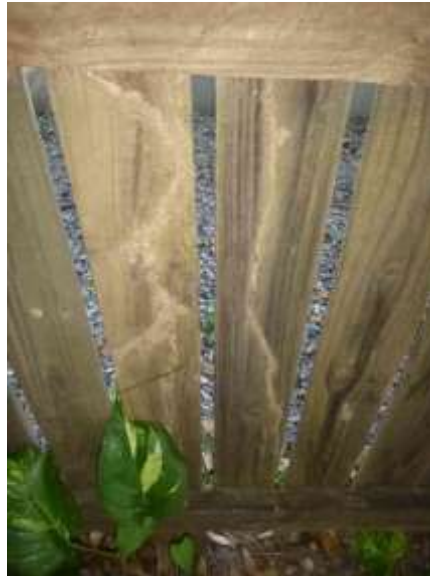
To sections of the timber boundary fence.

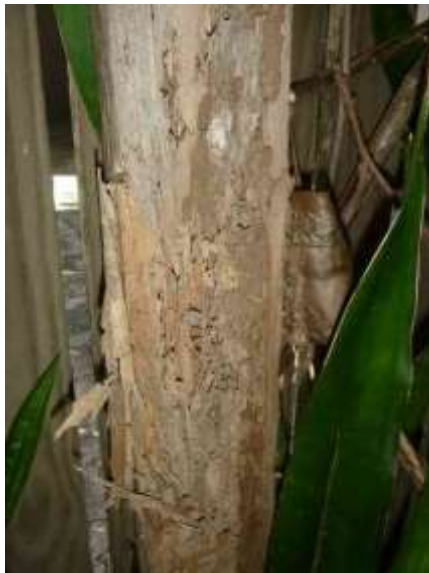
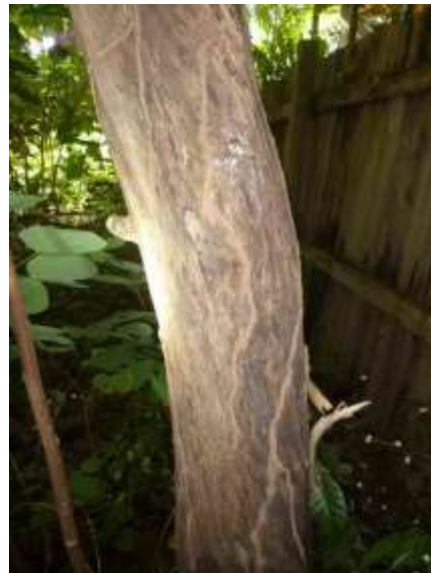
To various tree stumps in the back garden.

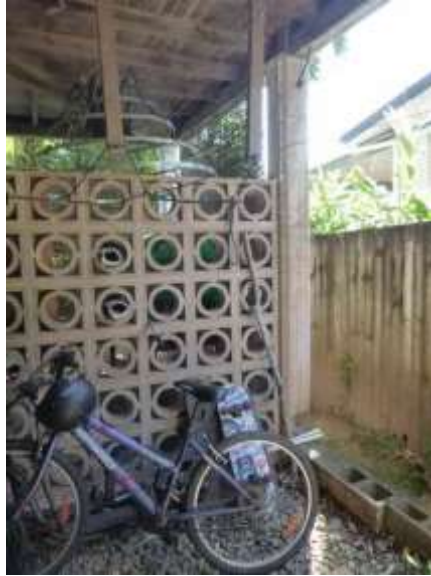
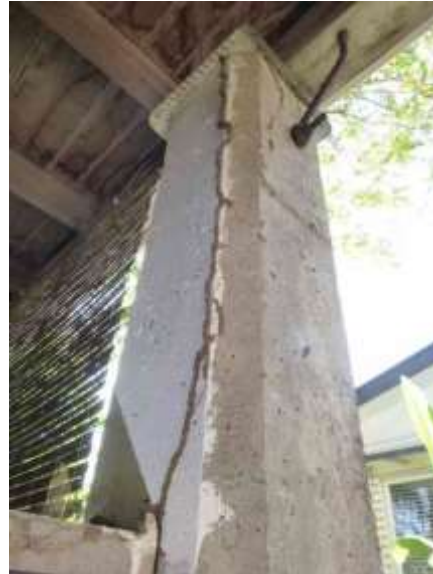
An inactive termite track was noted to one of the concrete pillars down the left hand side of the house.

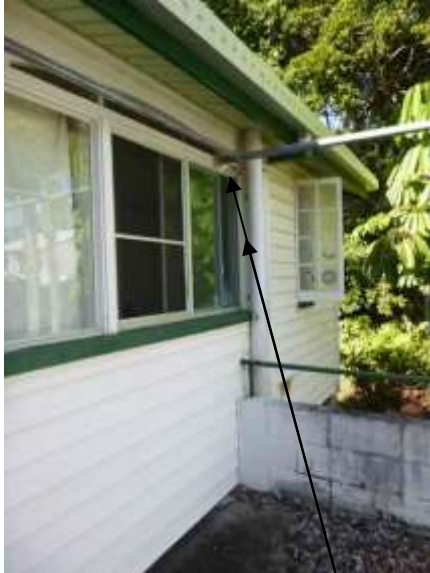
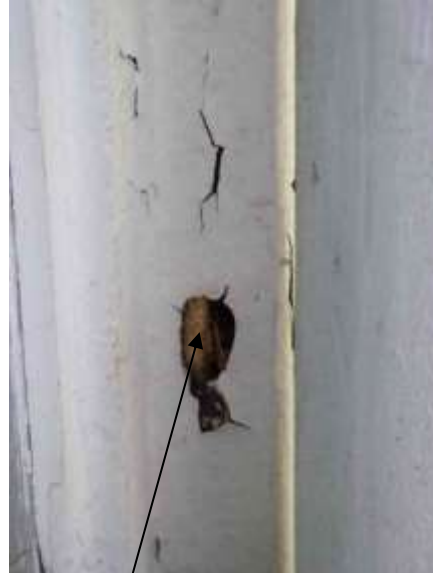
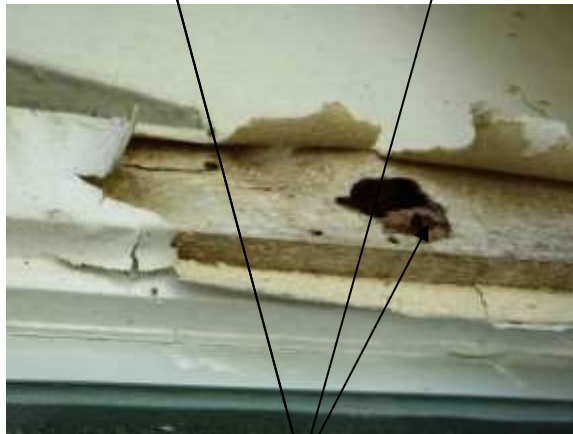
Termite damage was noted to the window frame down the right hand side of the house adjacent to the outside entertaining area.

This window frame here

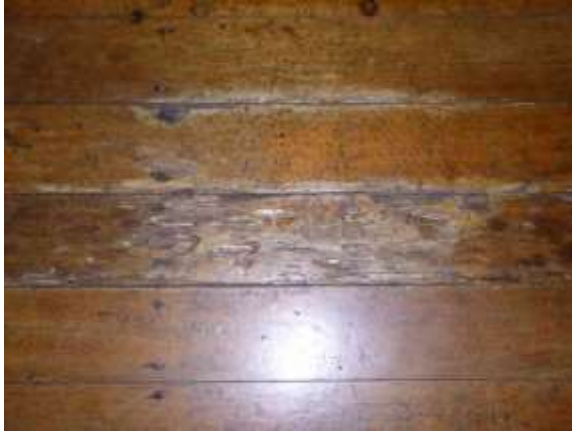
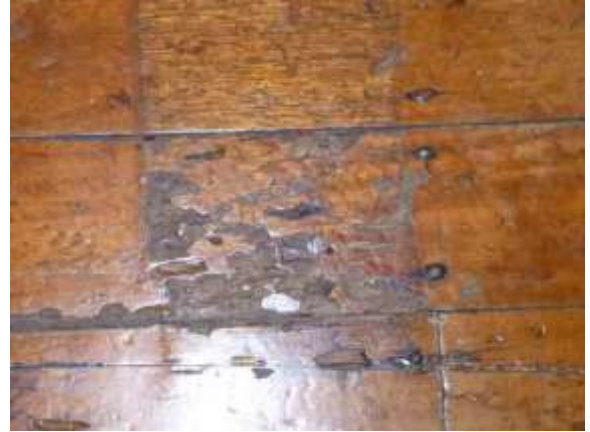
Drywood termite damage was noted to the floor boards in the kitchen.

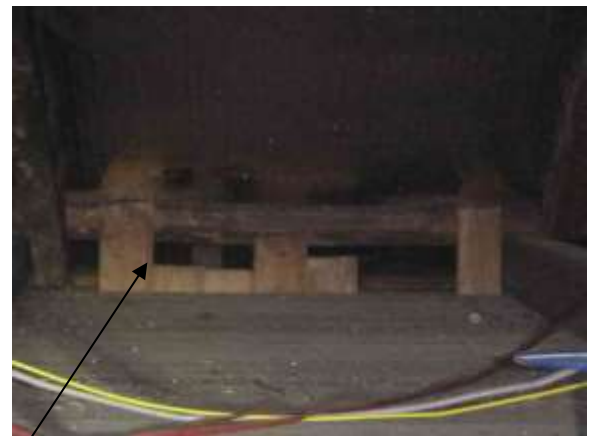
Termite workings were noted to a rafter and batten in the roof cavity.

Termite workings were noted on rafter and batten

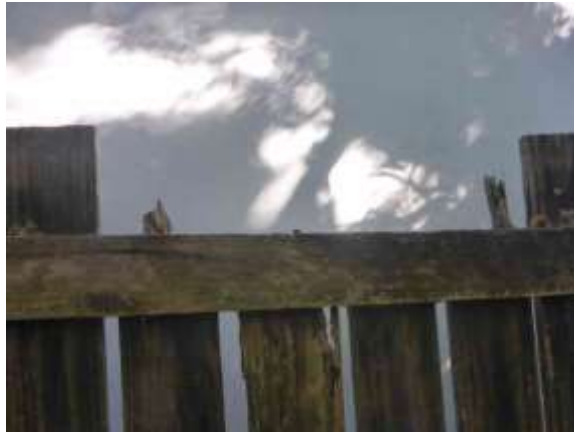
To sections of the fence palings.

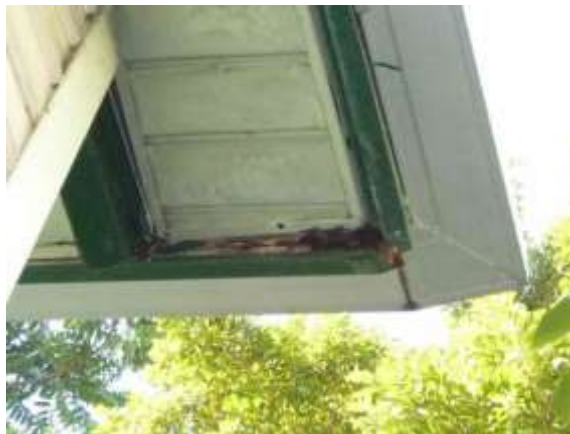
To sections of the fascias in various locations around the building.

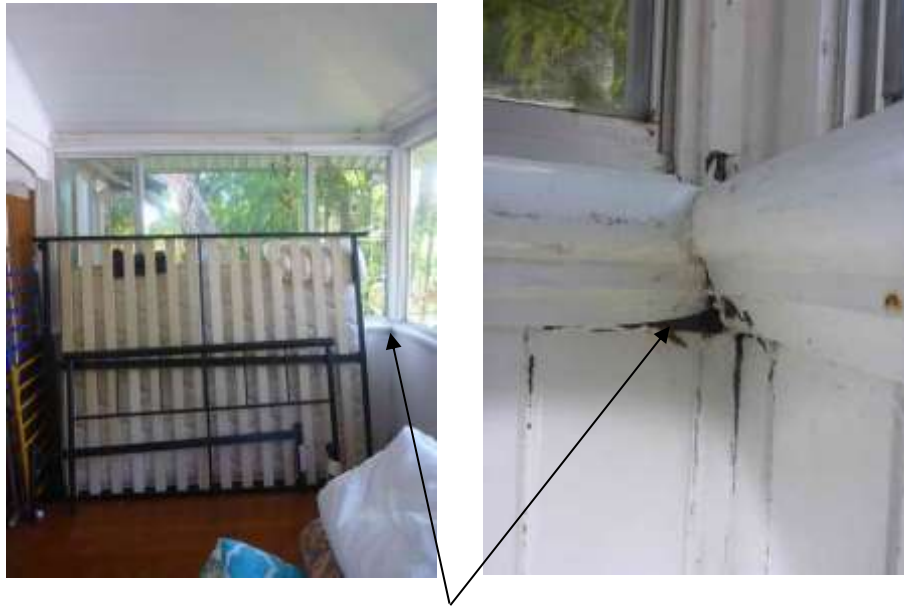
To the window sill in the front left hand corner of the building.

This section here

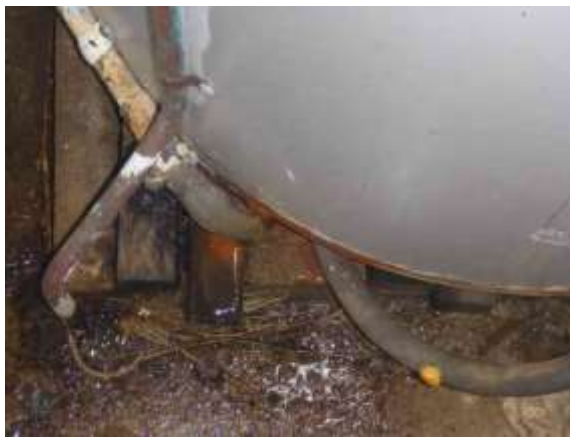
5.1 At the time of the inspection, **leaks were found to be present in The bottom of the hot water cylinder.**

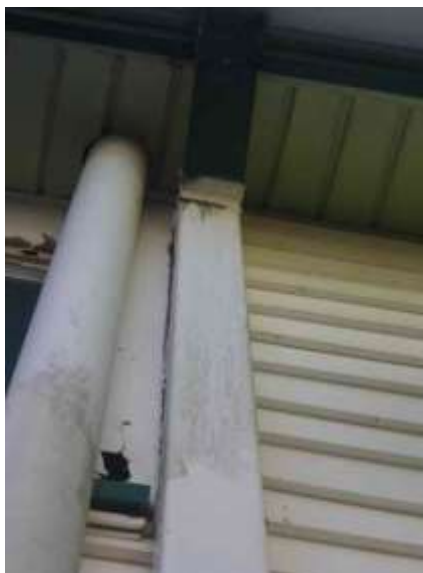
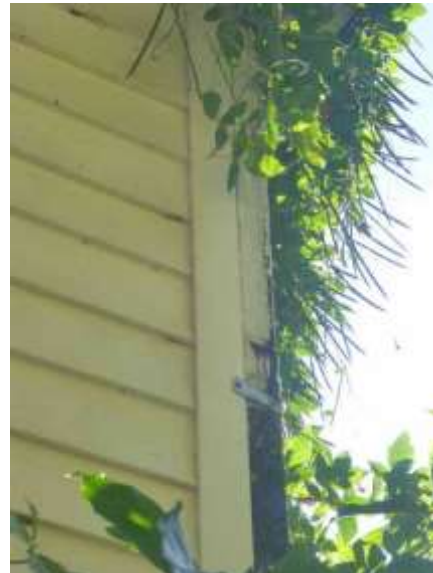
The down pipes in various locations around the building.

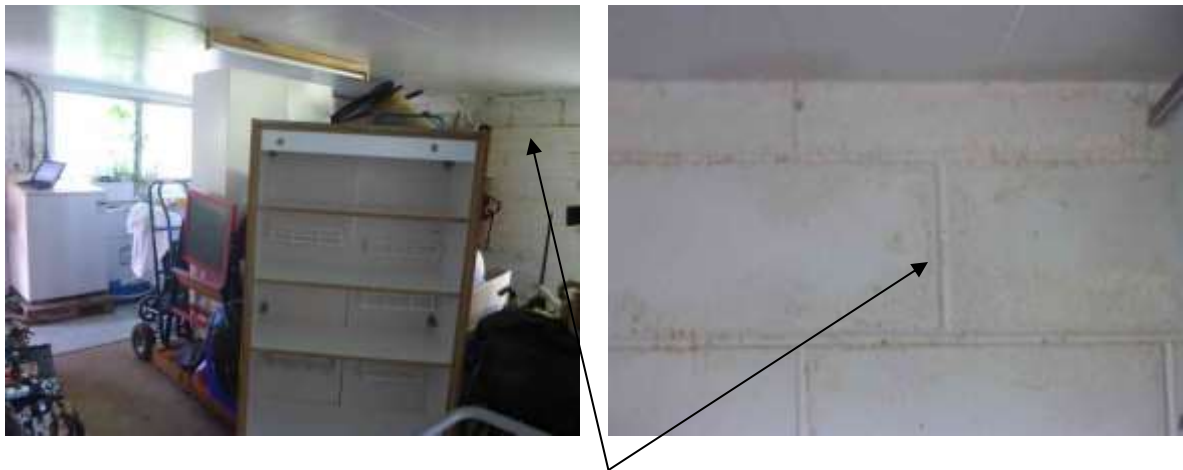
The walls inside the laundry area.

Internal walls of laundry

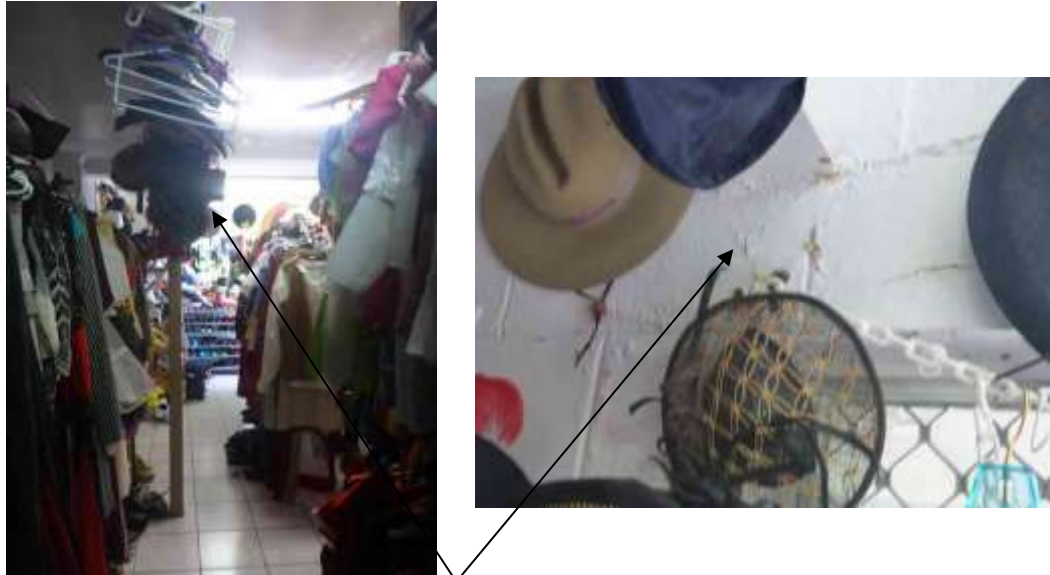
Internal wall adjacent to carport in front room of the downstairs flat.

This wall here

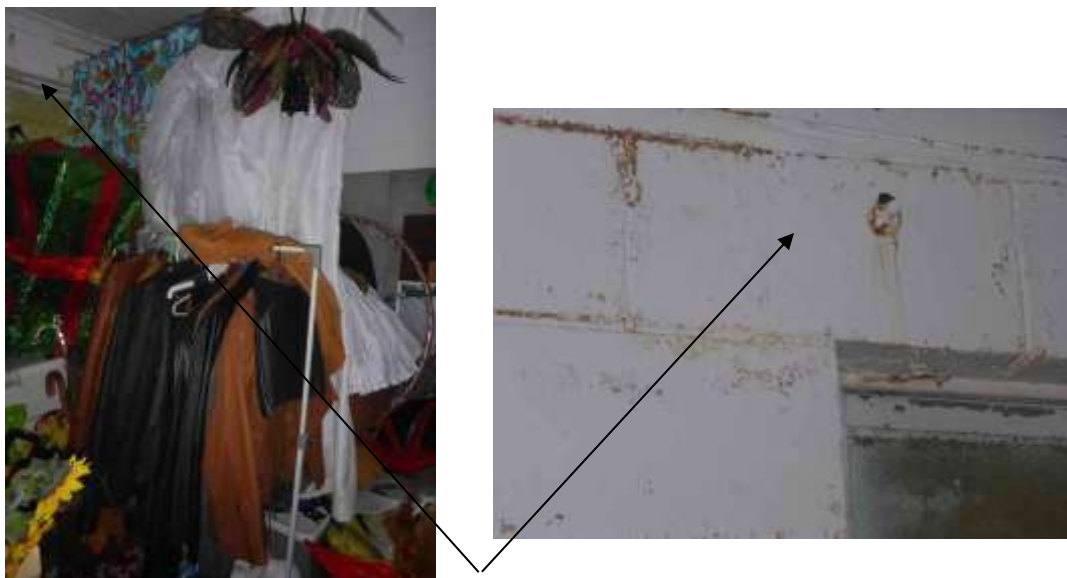
Internal wall adjacent to carport in bathroom of the downstairs flat

This wall here

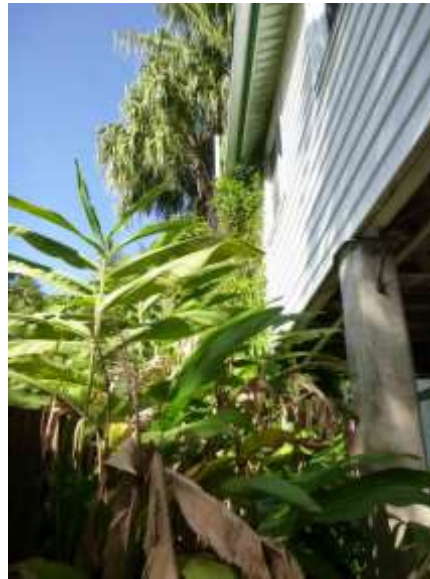
Mulched garden beds abutting external walls form a food source for termites. It is recommended that ALL garden beds / foliage touching the building be moved at least one meter away from the walls.

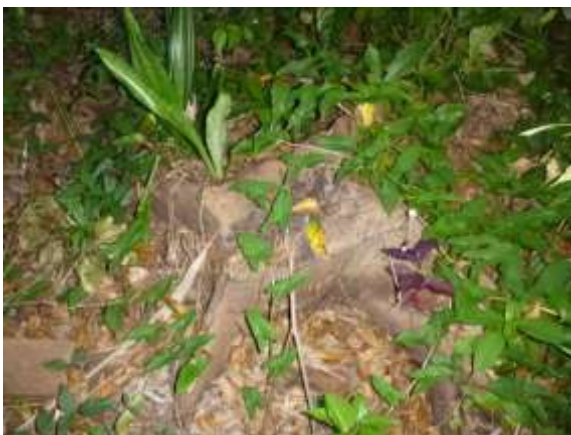
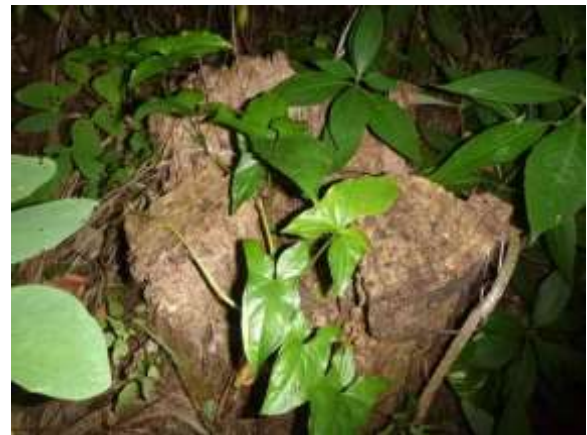
Decaying trees stumps / timber are an obvious attraction for termites. These should be removed from the garden beds AS THEY OCCUR and small (10mm) landscaping stones should be considered as an alternative to conventional mulch as they allow better percolation of water and are not an attraction for termites.
