## **"PRE-PURCHASE PROPERTY REPORT IN ACCORDANCE WITH APPENDIX C"**

As instructed, I have carried out an inspection of a two storey, six bedroom painted block / timber clad house in .....

## NORTHERN BUILDING INSPECTION CONSULTANTS

### 2.0 SUMMARY OF INSPECTION FINDINGS AND GENERAL OBSERVATIONS

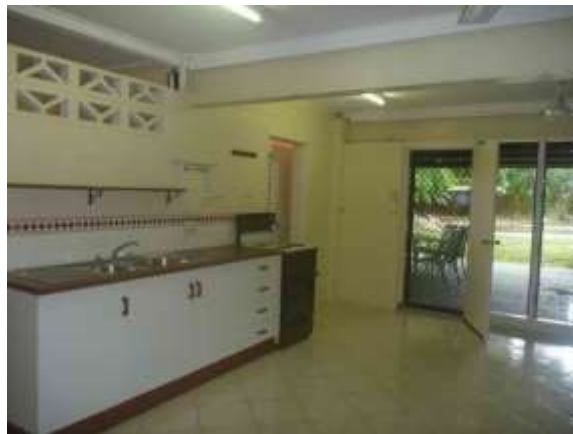
- (r) The downstairs kitchen had laminated bench tops with laminated doors and draws beneath which were in good condition for their age. It had a double stainless steel sink with conventional taps which had ample water pressure, there was good sealant to the splash back tiles and no signs of water leaks were noted beneath the sink. Only three of the four burners for the electric cook top were working at the time of the inspection but the windows and doors facing the side of the property closed and latched into place. The lights and fan were in good working order so no other obvious faults were noted here.

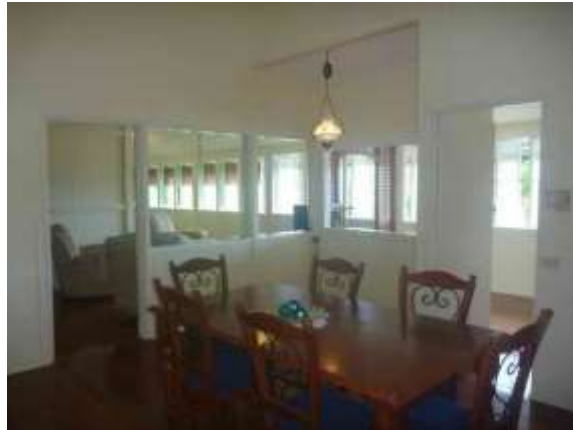
- (x) The first dining area was located next to the kitchen in an open plan style and it had two lights and a fan which all operate well. No obvious faults were noted here.

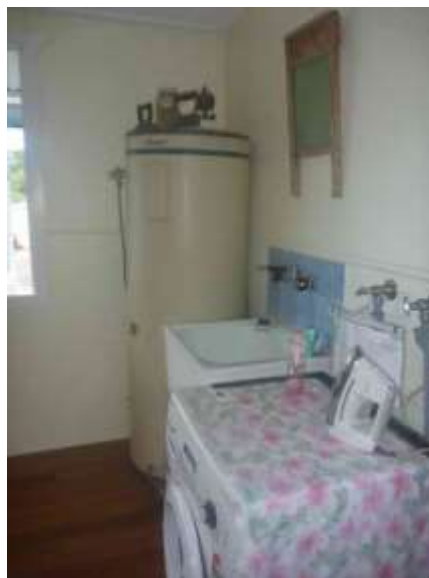
- (y) The laundry had a single plastic laundry tub which had ample water pressure to its conventional taps and no signs of leaks were noted beneath the tub. The light operated well but no floor waste was visible here so I am unsure where excess water would drain to in the event of a flood. No other obvious faults were noted here.

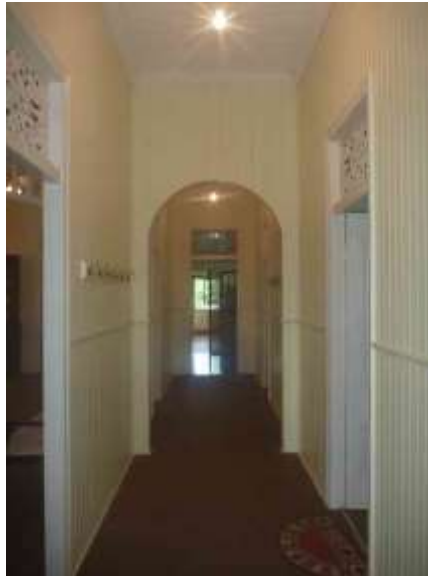
(dd) The central hallway had two lights and a smoke detector which all operated well.

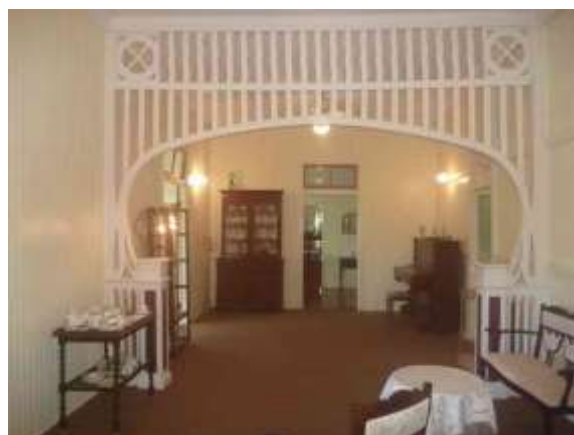
(ee) The formal dining area had five lights and two fans which all operated well. No obvious faults were noted here.

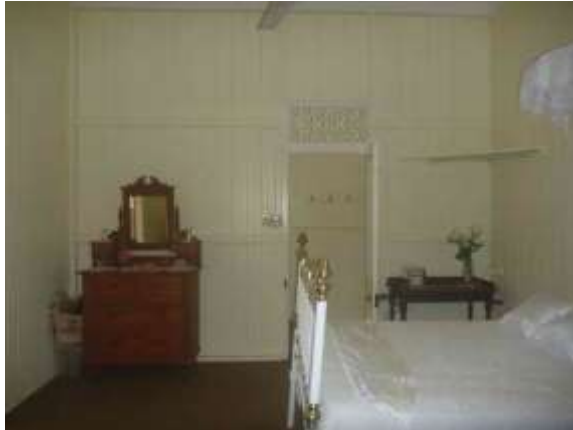
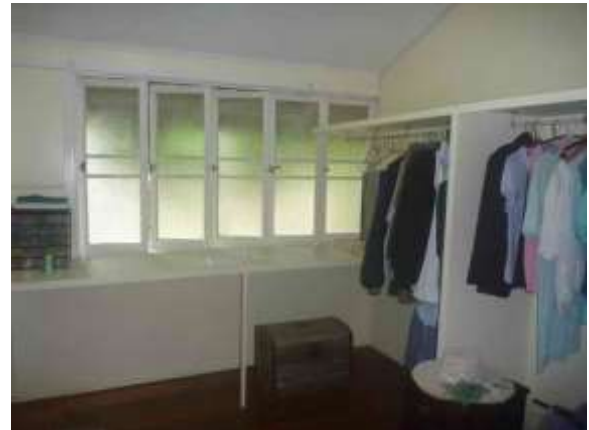
- (ff) The third bedroom had a single light and a fan which both operated well and the walk in robe here had secure shelving with hanging space beneath so no obvious faults were noted here.

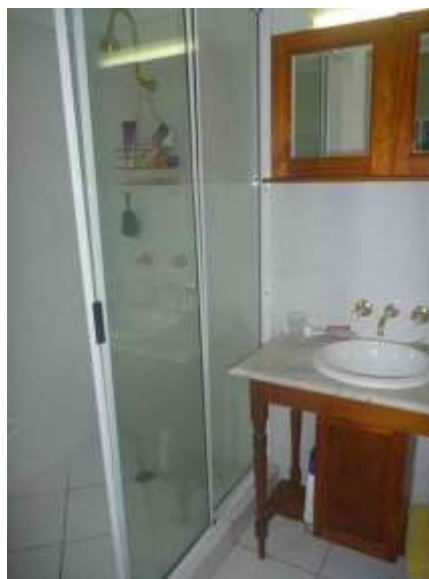
- (gg) The ensuite had a single sink vanity unit which had ample water pressure to its fixtures, there was good sealant to the splash back tiles and no signs of leaks were noted beneath the sink. The toilet was secure, flushed and did not leak and the corner shower had ample water pressure but as stated earlier it was leaking to the sub structure beneath which will need to be investigated further by an insured, registered plumber. Both the light and extractor fan were in good working order (the extractor fan was noisy though) so no other obvious faults were noted here.

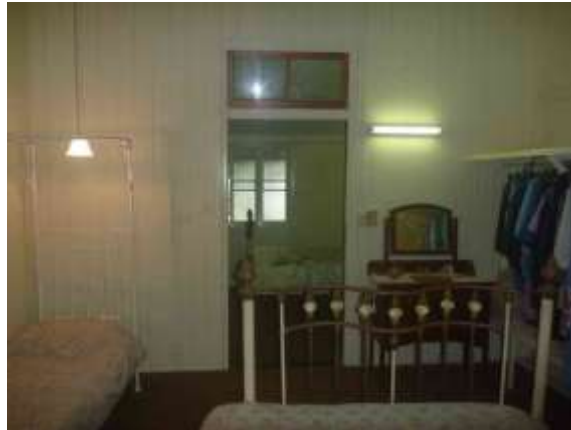
- (hh) The fourth bedroom had two lights and a fan which all operated well so no obvious faults were noted here.

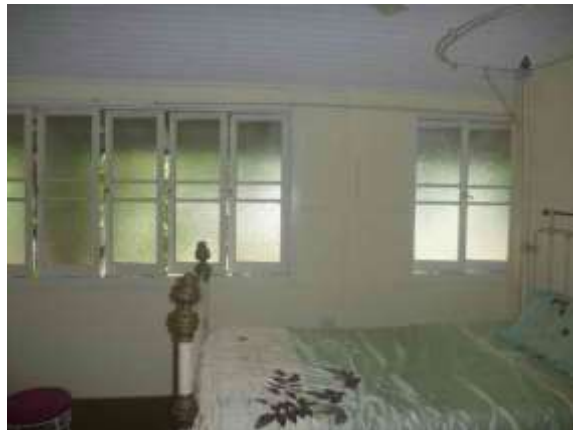
- (ii) The fifth bedroom had a single light and a fan which both operated well so no obvious faults were noted here either.

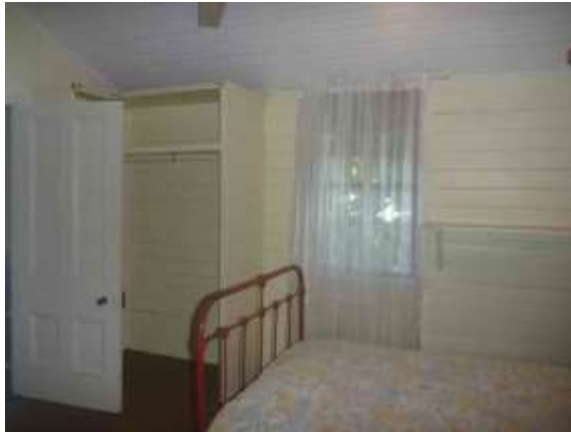
- (jj) The sixth bedroom had a single light and a fan which both operated well so no obvious faults were noted here.

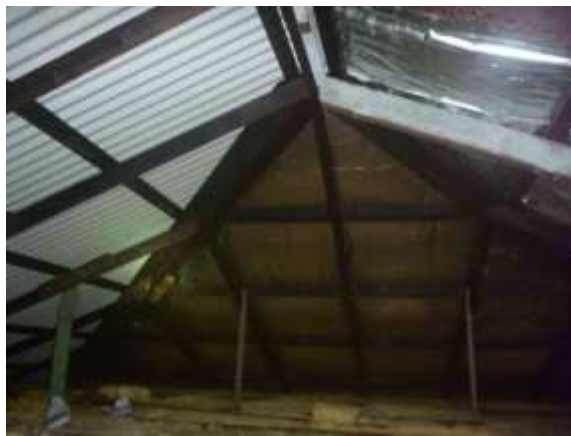
- (II) Up in the roof cavity the roof framing was an old style rafter design with only partial sarking noted to the underside of the iron but insulation batts were placed inside the cavity. The cyclone tie downs did not appear to have been upgraded when the roofing iron was replaced which should have occurred so please obtain a quotation for this work for budgeting purposes. There were no obvious signs of water penetration to the cavity so no other obvious faults were noted here.
